US Army Corps
of Engineers

Construction Engineering
Research Laboratory

CERL Technical Report 99/54
June 1999

Potable Water Pipe Inspection at Westover Air Reserve Base, Chicopee, MA

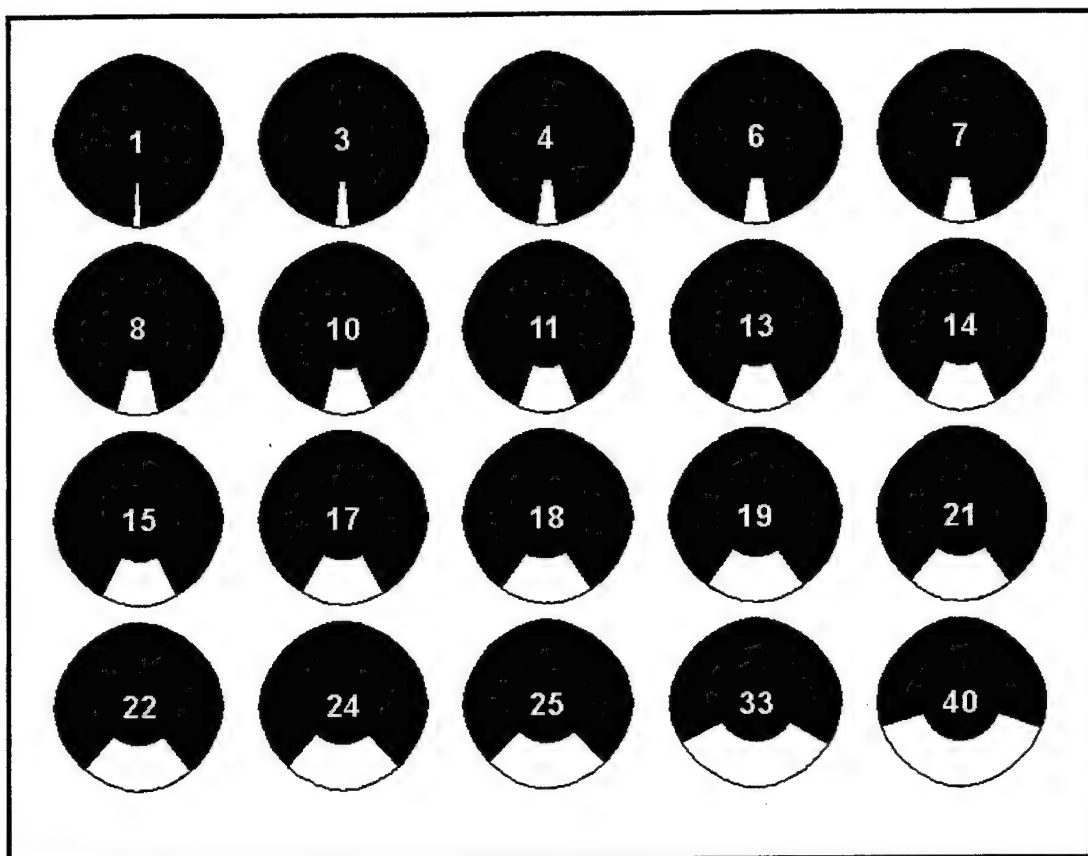
Figure 6. Coating loss estimating chart.

A loss-estimating chart (Figure 6) was developed to aid in estimating the amount of lining losses visible on the video. The videotapes were played back and the amount of missing lining was estimated for each 1-ft interval along the mains that were inspected. Table 5 lists the total length of each run and the average lining losses for each run for the first inspection visit. Appendix A contains the individual 1-ft coating loss estimates.
